Design of Crack Resistant Thermoplastic Roadway Markings

A thesis submitted to the Faculty of Graduate Studies and Research in partial fulfillment of the requirements for the degree of *Master of Science*

Department of *Chemical and Materials Engineering*

Fall 2002

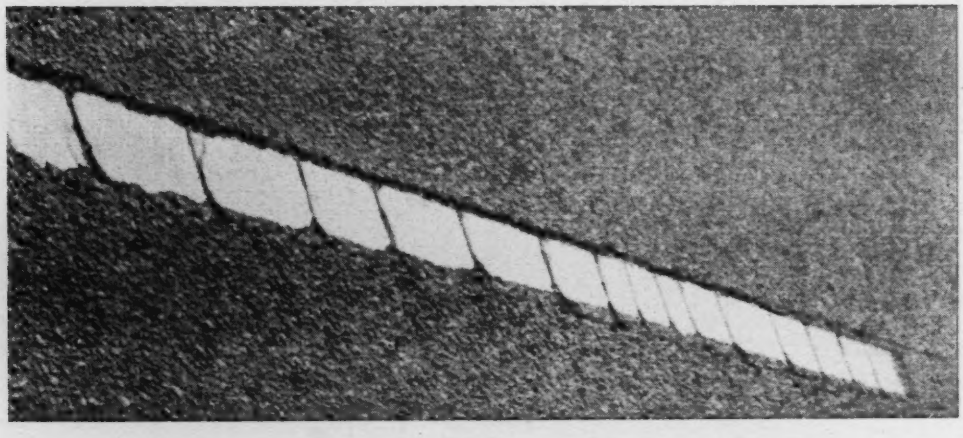
Figure 1.6: Raveling and Chipping Along the Edges

The second mode of failure is raveling and chipping along the edges of the markings as seen in Figure 1.6. This is noted to progress more rapidly as the marking ages and is also noted along the cracked edges over time.

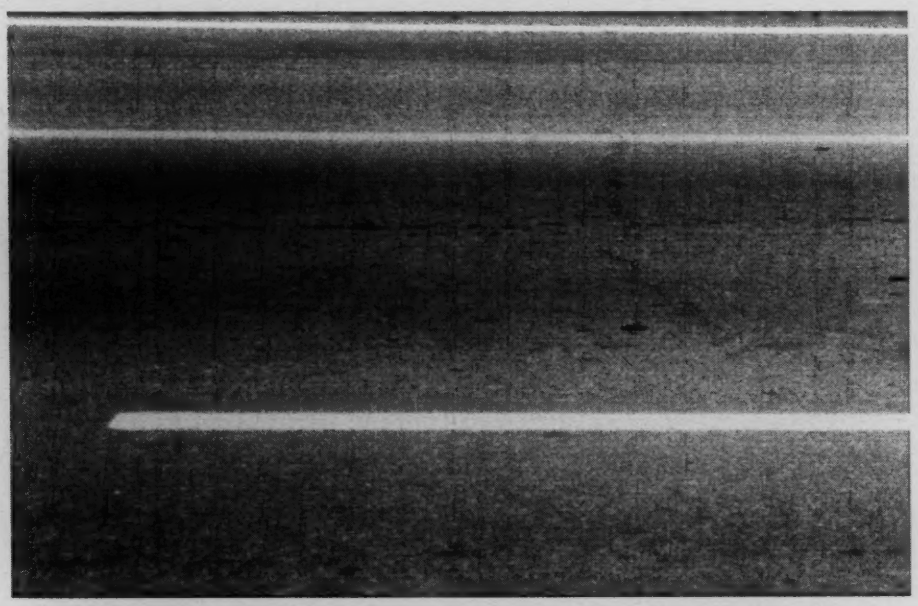
Figure 3.2: Transverse Cracking with Adequate Adhesion

completely functional. If the mechanisms of transverse cracking cannot be eliminated, the alternative is to ensure that the adhesion is adequate enough to result in a marking that will remain functional for a long period of time. Ensuring adequate adhesion will also reduce chipping and erosion along the outside and crack edges.

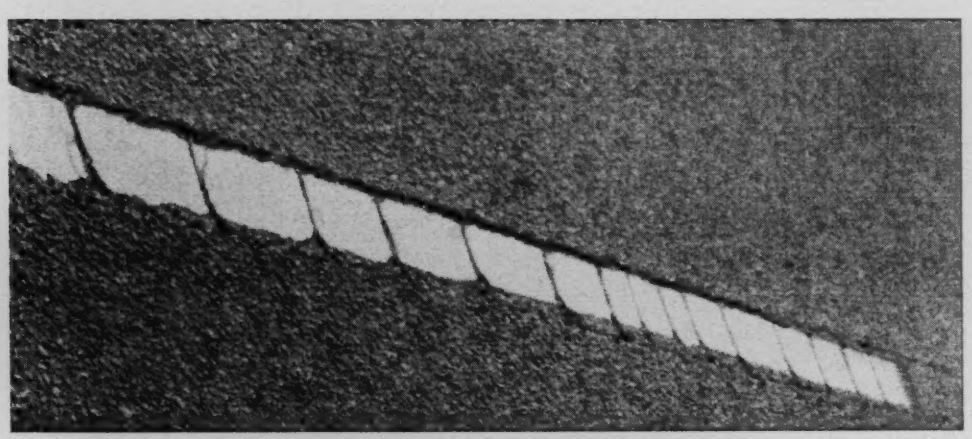
Figure 3.3: Aged and Chipped Marking

As a marking remains on the roadway, it is subject to numerous conditions that ultimately result in its deterioration. Figure 3.3 represents an aged and severely cracked marking. It is important to note that although this marking is severely cracked, it is still functional, once again, due to adequate adhesion to the asphalt concrete. The outside and crack edges show chipping due to erosion of the asphalt concrete-marking bond, which occurs over time as water and dirt migrate under the marking.

The upper edge of the marking in Figure 3.3 exhibits extreme deterioration at the marking-asphalt concrete interface. Cracking of the asphalt concrete along the edges of the marking occurs since the marking is a white stripe on a black surface. The marking reflects the sun's heat while the asphalt cement absorbs it. This creates an extreme in the thermal expansion properties of the asphalt cement, which is not shared with the marking, causing a crack to develop in the asphalt cement. (Dale, 1988)

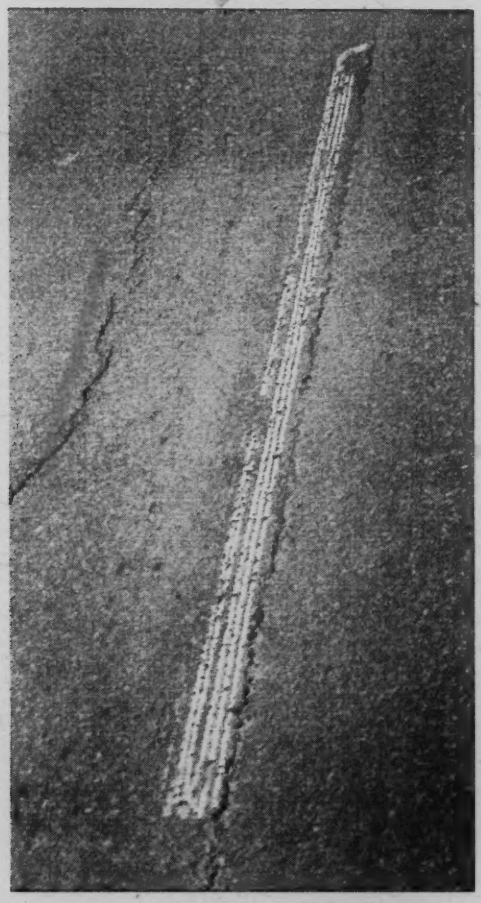
Figure 3.5: Severe Abrasive Damage

function to separate lanes, and was not completely removed. However, the marking is now much more susceptible to chipping and lesser abrasive forces.

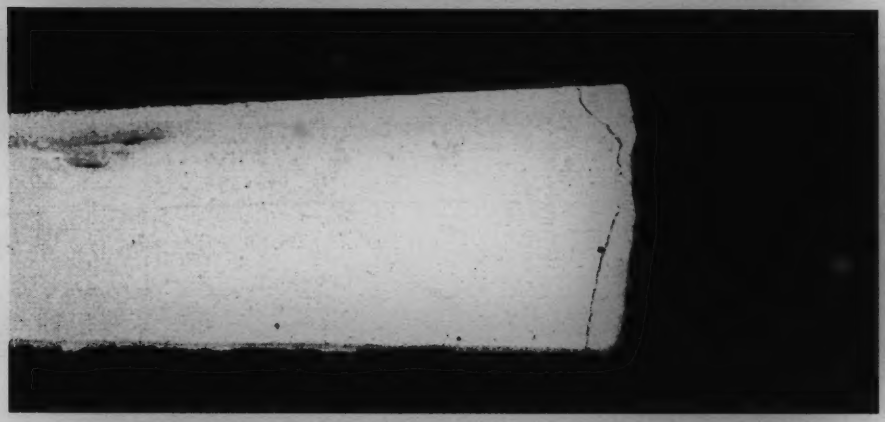
Figure 3.6: Air Void Cracking at the Leading Edge

A marking, which is not properly applied, will result in a reduction of the bond strength between the marking and the asphalt concrete. This will result in a slight air void between the marking and asphalt concrete, which when driven over by traffic, will

be compressed causing the marking to fracture. Figure 3.6 illustrates this phenomenon, showing cracking along the leading edge.

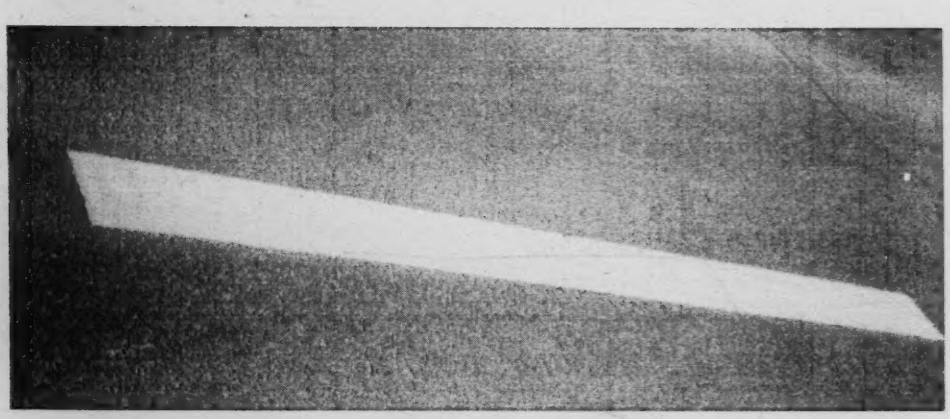
Figure 3.7: Marking After One Year Exhibiting No Transverse Cracking

Markings applied correctly in low traffic areas show extreme resistance to transverse cracking. Figure 3.7 is a photograph of a marking applied in a residential neighbourhood with an average annual weekday traffic (AAWT) rate of approximately 5000 vehicles per weekday. The photograph was taken one year after the markings application in Edmonton.

This marking has been through one complete winter cycle where temperatures were extremely low (-35°C) for extended periods of time. However, due to the location of the marking, traffic volume was minimal. This is an indication that transverse cracking occurs via multiple mechanisms and that cold temperatures alone are not sufficient to cause cracking. Traffic volume above a threshold limit must also be present.
